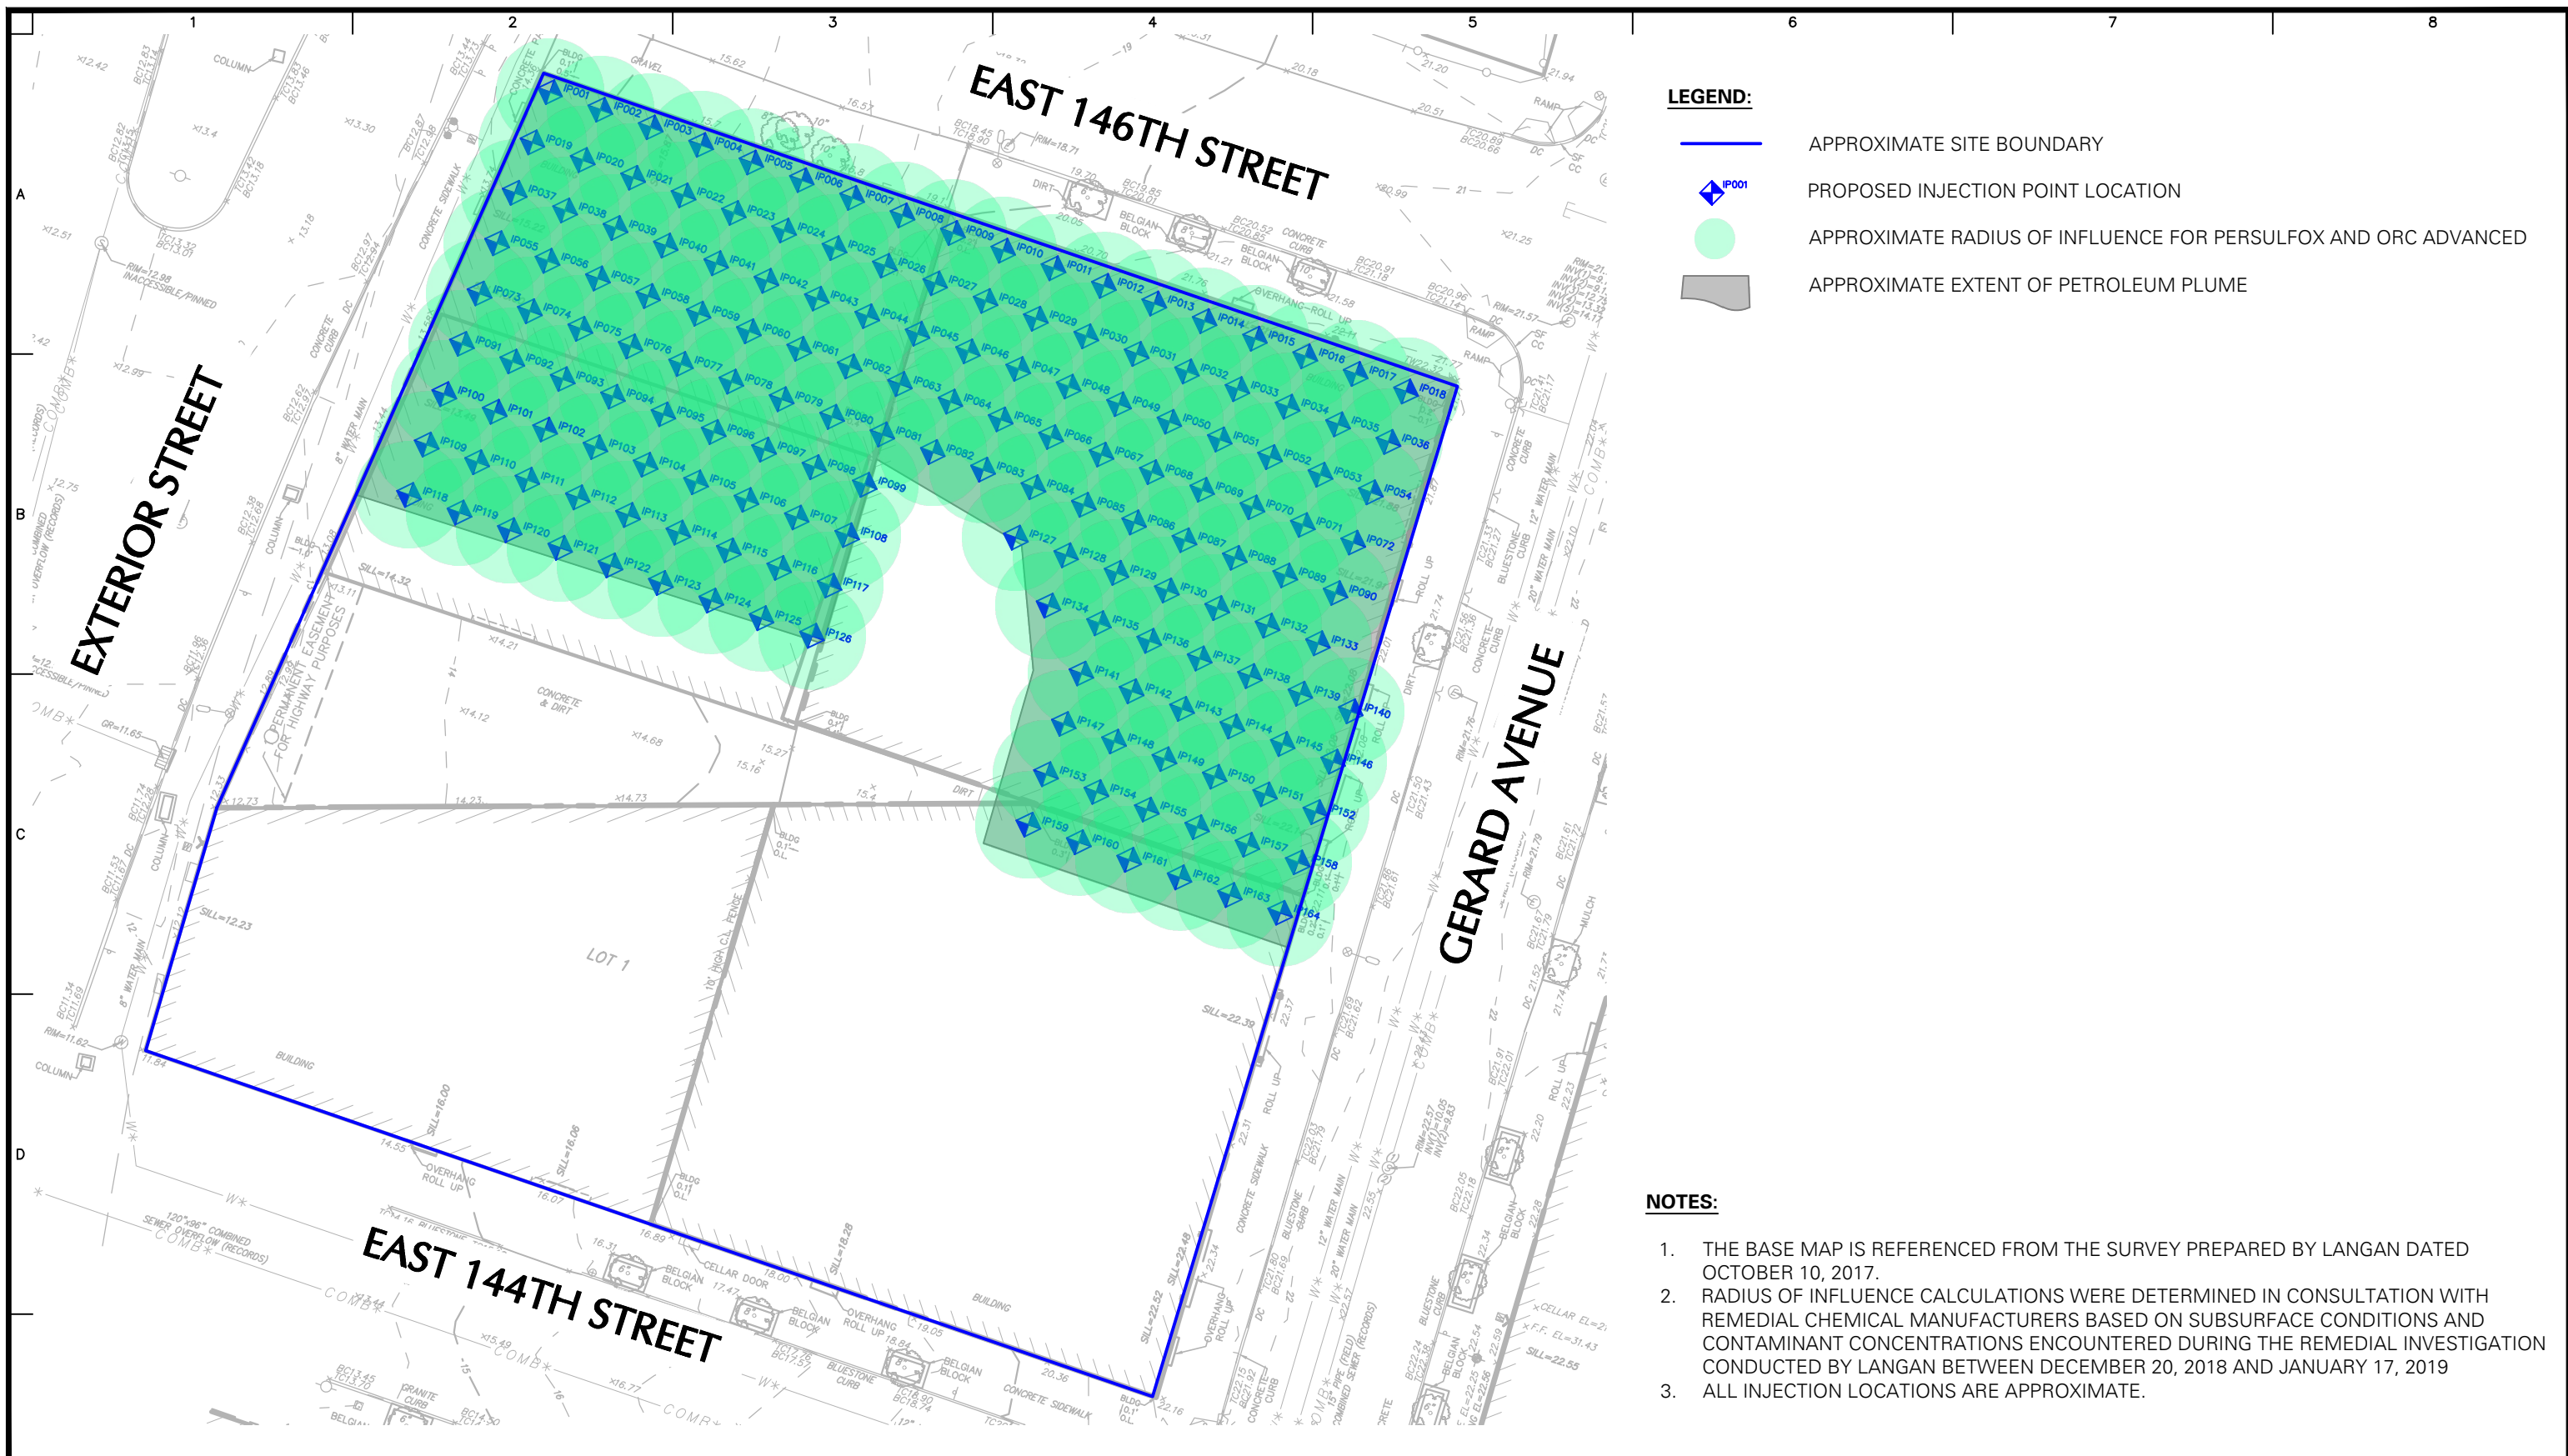
- APPROXIMATE SITE BOUNDARY
- ◆ IP001 PROPOSED INJECTION POINT LOCATION
- APPROXIMATE RADIUS OF INFLUENCE FOR PERSULFOX AND ORC ADVANCED
- APPROXIMATE EXTENT OF PETROLEUM PLUME

1. THE BASE MAP IS REFERENCED FROM THE SURVEY PREPARED BY LANGAN DATED OCTOBER 10, 2017.
2. RADIUS OF INFLUENCE CALCULATIONS WERE DETERMINED IN CONSULTATION WITH REMEDIAL CHEMICAL MANUFACTURERS BASED ON SUBSURFACE CONDITIONS AND CONTAMINANT CONCENTRATIONS ENCOUNTERED DURING THE REMEDIAL INVESTIGATION CONDUCTED BY LANGAN BETWEEN DECEMBER 20, 2018 AND JANUARY 17, 2019
3. ALL INJECTION LOCATIONS ARE APPROXIMATE.

A remedial design investigation was completed in May 2019 that included soil and groundwater sampling for use in a soil oxidant demand (SOD) test. Based on sample results, ISCO and oxygen release compound were selected to provide rapid and sustained degradation of the targeted petroleum-related VOCs and SVOCs. Soil below the groundwater table and groundwater will be treated with one round of ISCO (PersulfOx[®]) followed by a second round of combined ISCO and oxygen release compound (ORC Advanced[®]). ISCO and oxygen release compound will be applied directly to the petroleum-impacted soil and groundwater via about 160 temporary injection points or direct mixing with an excavator in the northern half of the site. The approximate treatment area is shown on Figure 12. The treatment depth will target the approximate depth of saturated zone petroleum impacts (assumed to be about 11 to 20 feet bgs on Lot 3 and 18 to 28 feet bgs on Lots 12 and 20).

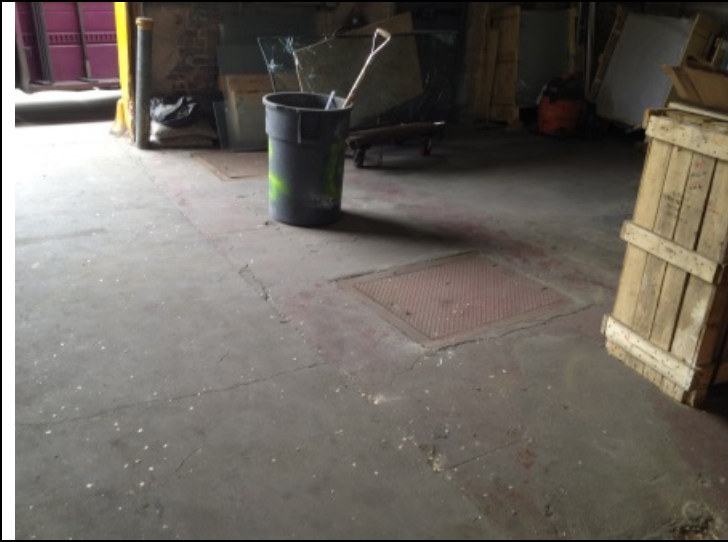
PHOTO 5: Looking at the cover of the oil-water separator within the building.

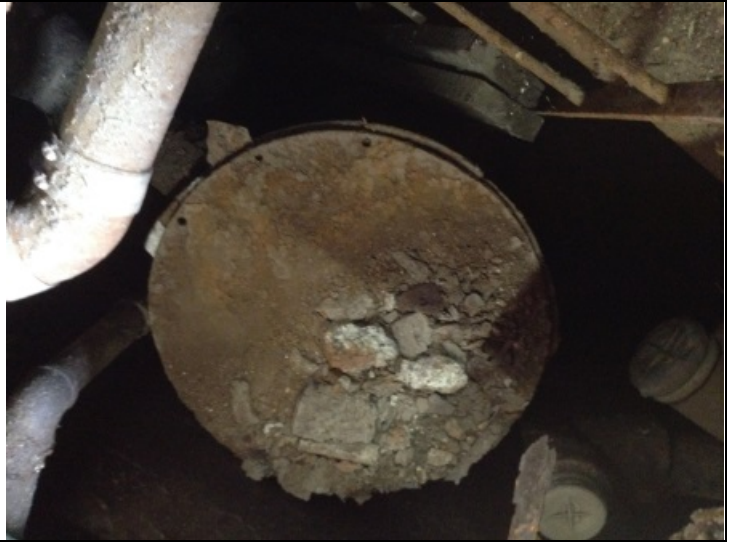
PHOTO 6: View of the oil-water separator.

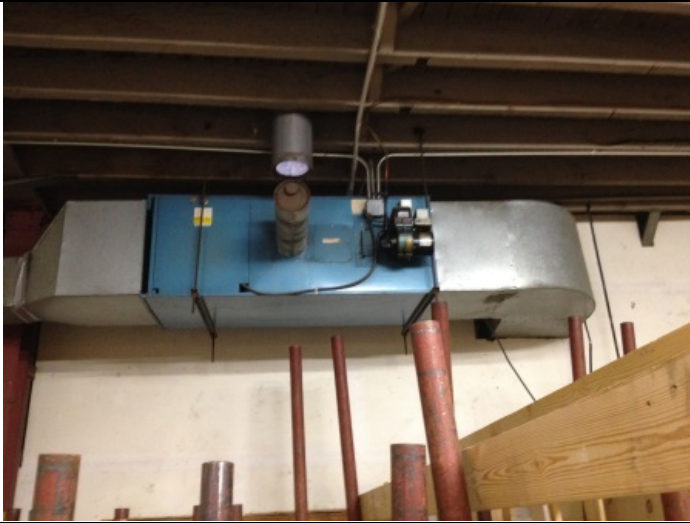
PHOTO 7: Looking at the oil-fired hot air blower heating system.

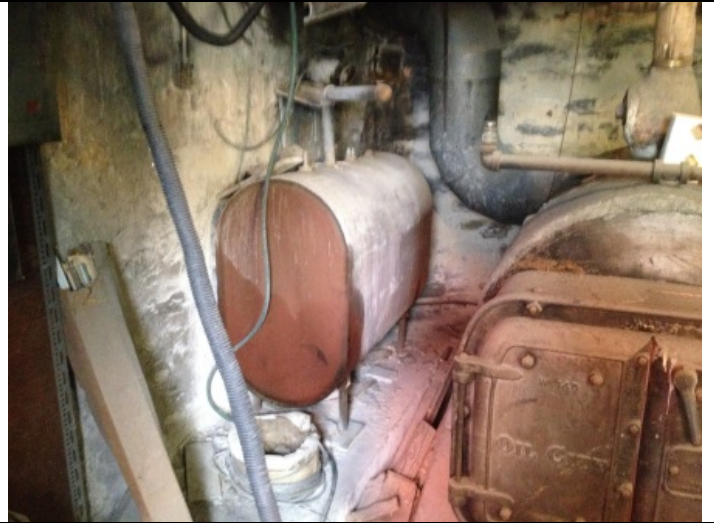
PHOTO 8: Looking at the oil tank associated with the oil fired hot air blower heating system.

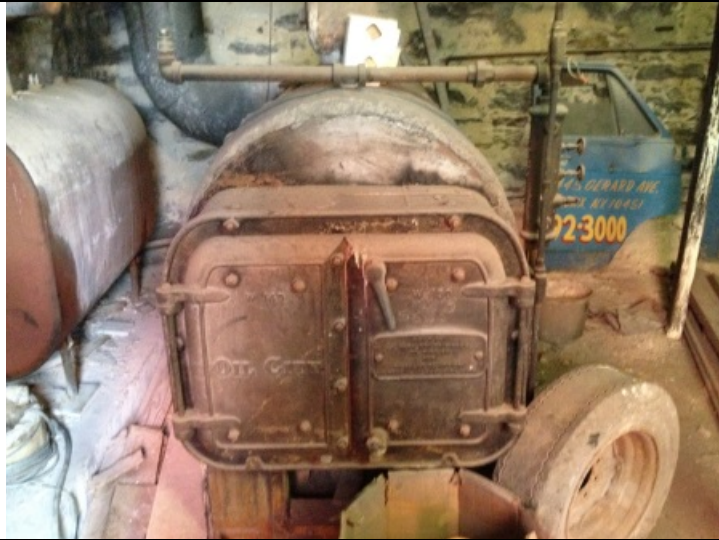
PHOTO 9: Looking at the dilapidated boiler within the building.

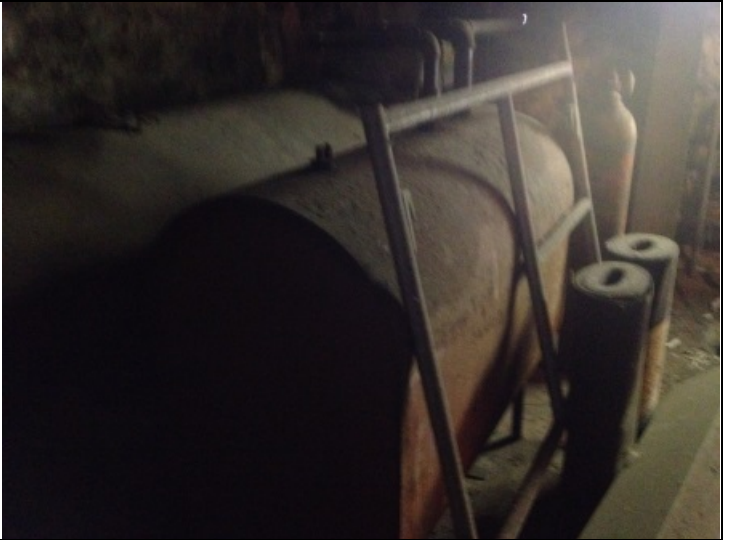
PHOTO 10: Looking at a second 275-gallon AST and behind that is another AST encased within concrete.

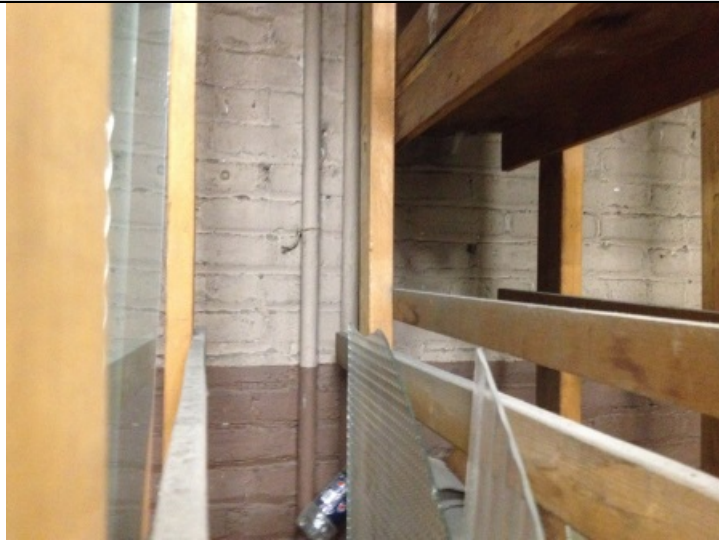
PHOTO 11: Looking at two gas tank vent lines that run up along the front wall of the building.
